# STABILIZATION OF LEAD AND ZINC FLOTATION CIRCUITS AT GALMOY MINE, KILKENNY, IRELAND

MIKE HALLEWELL, NIGEL MACDONALD AND ROBERT THORPE — SGS; AND PAUL LAFRAMBOISE, ARCON MINES LTD.

Galmoy Mine, owned by Arcon Mines Limited, has operated since 1997, and is one of three operating lead/zinc mines in Ireland. Changes in ore type starting in mid 2002 created challenges to metallurgical operations at Galmoy. This resulted in unacceptable lead and zinc flotation performance, which prompted initiation of a formal plant review and a subsequent stabilization programme. This involved a structured review of operational practices, development of a new Standard Operating Procedure (SOP) which in turn led to significant changes in process control equipment needs in conjunction with extension of zinc flotation cell residence time.

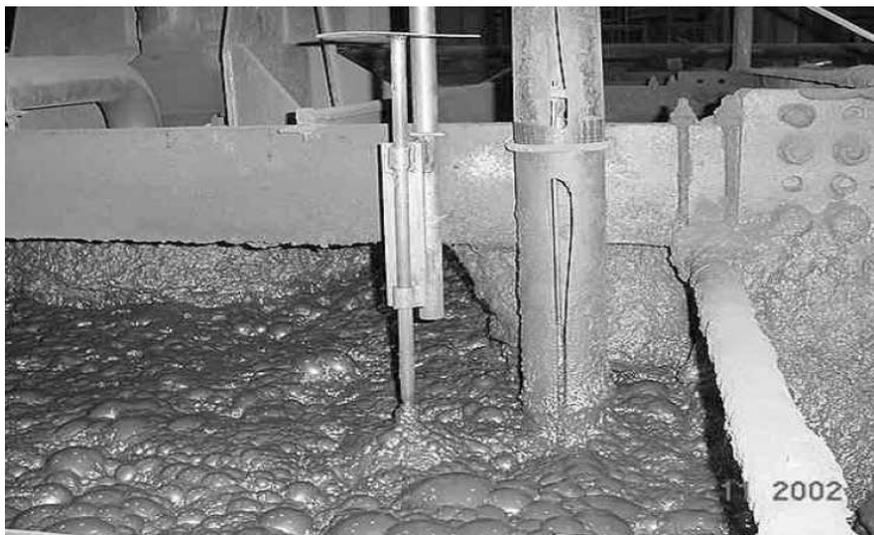
Figure 13: New Level Control system and old tube type system alongside

The lead circuit contained two level controllers whilst the zinc circuit contained seven level controllers. The problem with the existing design level controllers was that the floating plastic ball connected to a target plate was encapsulated in a tube. The tube was continuously becoming scaled up with froth and exasperated by lime scale in the zinc circuit. As a consequence the ball would stick in the tube and the dart valves would open, promptly dumping the contents of the cells downstream. This occurrence would happen at least once a shift on one of the nine level controllers within the plant.

As a consequence, we designed a tubeless floating ball system (refer to Figure 13) with target plate and ultrasonic detector and installed this in the lead rougher cells in November 2002. The trial was so successful that within a week, the operations group demanded all the others to be retrofitted. This was completed by January 2003 and instability due to level control became a thing of the past.

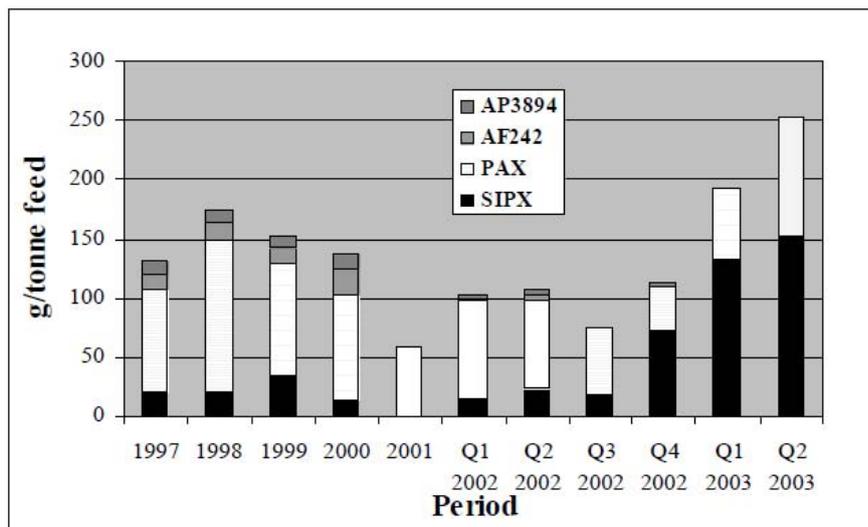
Figure 16: Collector Dosage Ramp up as New Reagent Pumps arrive Q1 2003

Figure 16 above clearly shows the impact of installing the new reagent pumps in the first quarter of 2003.

Subsequently, reagent blockages are now rare and another form of plant instability was ironed out.

Based upon this experience with the trial pump, in December 2002, eight new Watson Marlow Peristaltic pumps were ordered in order to ensure that all reagents were being dosed via metering pump.

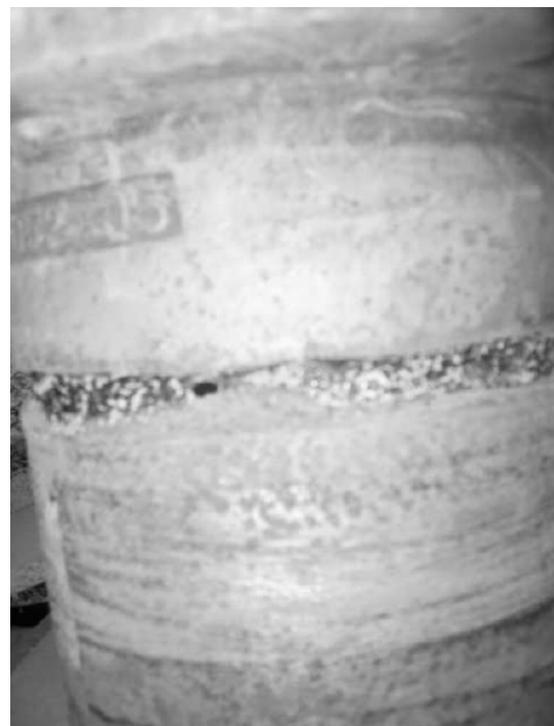
Figure 17: Holed Vortex Finder

As mentioned previously, another source of plant instability was lack of preventative maintenance to hydro cyclones, particularly the primary hydro cyclones. The mechanical department according to their scheduled plans was regularly carrying out maintenance; the problem was that this procedure had no metallurgical input as to when and why the internal components should be changed. The only occasion that the operational group became aware of a problem was when the flotation cell dart valves regularly blocked and the false bottoms below the Wemco cells eventually filled up with sand which subsequently scaled to a proud concrete mix and resulted in very poor cell recirculation of pulp requiring air lances to free up tanks etc. This small attention to detail caused a major downstream instability and wasted effort. As a consequence, the mechanical department would assume that provided the hydrocyclone had a rubber lining and the vortex finder was not holed, then they had done their job. Therefore, hydrocyclone vortex finders regularly holed (see Figure 17 below), and the rubber internals were being changed as

the mechanical department saw fit, but this left significant steps in the joints between the new and old components which caused turbulence, increased wear and generated coarser overflow size distributions than necessary.

on vortex finders in particularly onerous duties is the cutting of the vortex finder around its base which if left unchecked can ultimately result in the vortex finder actually falling off into the hydrocyclone vessel itself. This phenomenon is most usually associated with lack of attention to cover plate liner wear. Once the cover

plate liner becomes worn around the vortex finder, it creates a strong swirling action locally in this area and rapidly reduces vortex finder life.

As a consequence of the above, the metallurgical group were made responsible for managing hydrocyclone maintenance working with the mechanical department. It soon became clear that vortex finder life was circa 3 months with new cover plate liners. The increased focus in this area resulted in a steady flotation feed size distribution and minimized instability within the flotation plant.

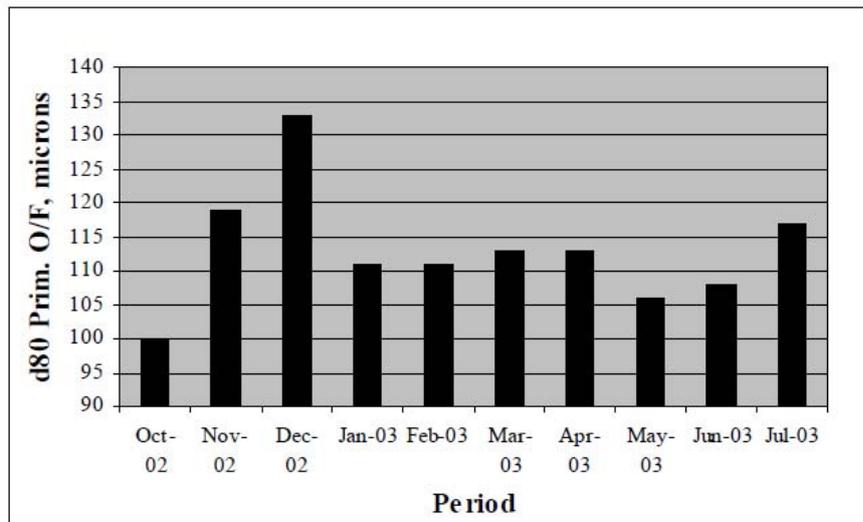
Figure 18: Primary Hydrocyclone Over.ow Average Monthly Sizings

Figure 18 captures the problem with vortex finders in December 2002 and shows how relatively stable the flotation feed was post introducing the new hydrocyclone maintenance initiatives in January 2003. Dart valves blocking due to coarse feed and unnecessary losses due to over sized feed distributions became a thing of the past.

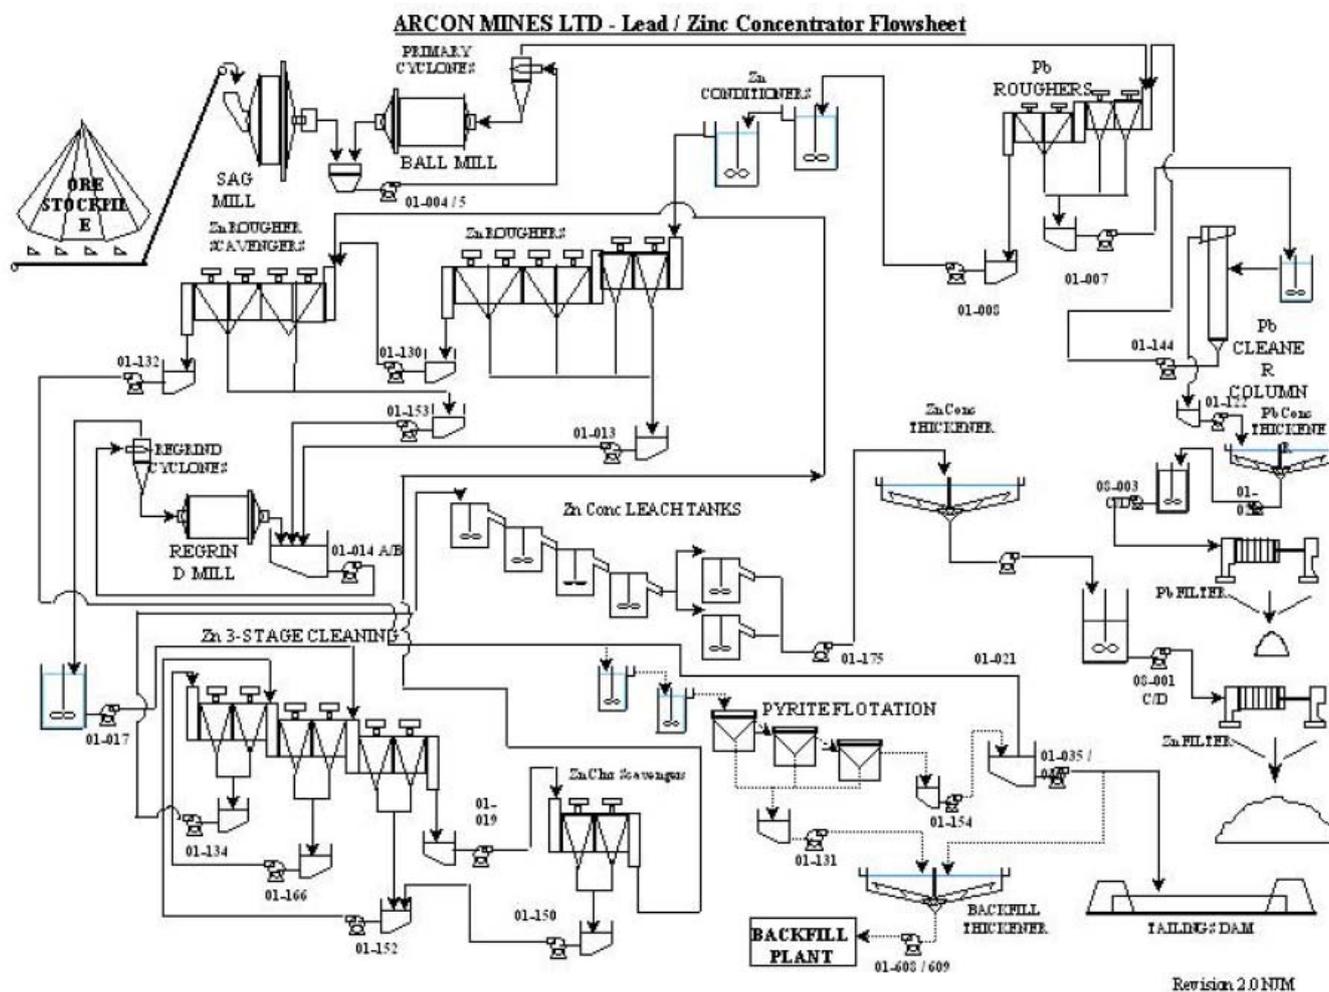
Figure 19: Flow sheet as of September 2002

- The SAG mill - Ball mill circuit did not cater for critical size
- The Lead Circuit only had one stage cleaning in a column
- The Zinc Circuit Rougher and Cleaner Scavenger flotation cells were shared.

The increased throughput rate was resulting in flotation feed d80's of circa 110 microns.

Figure 19 above shows the status of the flow sheet as of September 2002.

The single cleaner lead circuit was unable to produce saleable concentrate grade and the attempts to build up a circulating load of lead between the lead rougher and lead column in order to attempt to make saleable lead grade were futile. The lead column level control and air spargers were a constant source of operational instability and the frequent dumping of the column contents back into the lead rougher caused significant lead contamination in the downstream zinc circuit. As a consequence, it was decided at an early stage, to iron out this instability and cease futile attempts to make lead concentrate grade. As a consequence, the lead rougher concentrate was pumped directly to the total tailings box via the OSA .

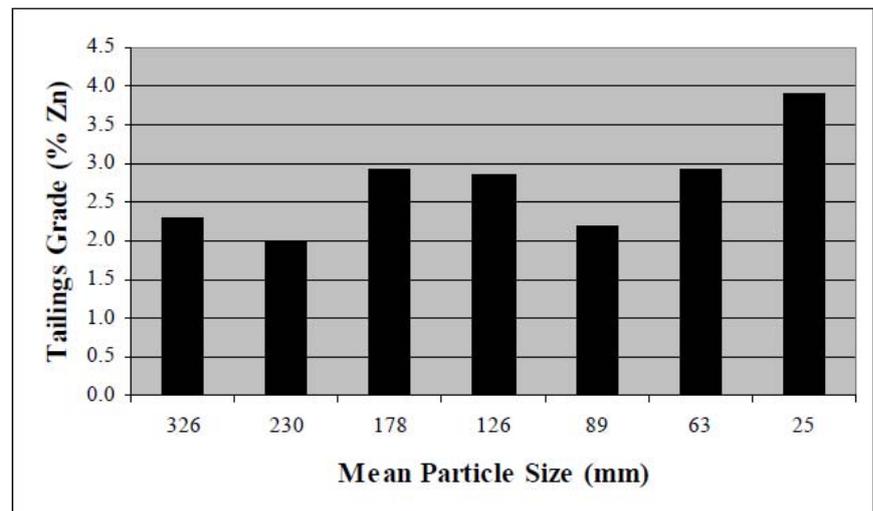
Figure 22: Total Tailings Zinc Grade by Size

The total zinc tailing Monthly composite sample for August 2002 is shown below (refer to Figure 22), and clearly shows that the zinc assay by size is relatively constant across all size fractions, suggesting that the flotation process was incomplete.

Subsequent mineralogical examination of September mill composite samples supported the fact that the majority of the zinc losses were liberated sphalerite and supported the feeling that the plant was operationally unstable and lacked cell residence time. Subsequent laboratory flotation test work carried out on existing cleaner scavenger and zinc rougher tailings prior to them being combined and pumped through the shared flotation bank indicated that Process Control data from the On Stream Analyzer was limited and only gave total zinc recovery information. This restricted the capability of the operators when it came to real time decision-making.
