# STABILIZATION OF LEAD AND ZINC FLOTATION CIRCUITS AT GALMOY MINE, KILKENNY, IRELAND

MIKE HALLEWELL, NIGEL MACDONALD AND ROBERT THORPE — SGS; AND PAUL LAFRAMBOISE, ARCON MINES LTD.

Galmoy Mine, owned by Arcon Mines Limited, has operated since 1997, and is one of three operating lead/zinc mines in Ireland. Changes in ore type starting in mid 2002 created challenges to metallurgical operations at Galmoy. This resulted in unacceptable lead and zinc flotation performance, which prompted initiation of a formal plant review and a subsequent stabilization programme. This involved a structured review of operational practices, development of a new Standard Operating Procedure (SOP) which in turn led to significant changes in process control equipment needs in conjunction with extension of zinc flotation cell residence time.

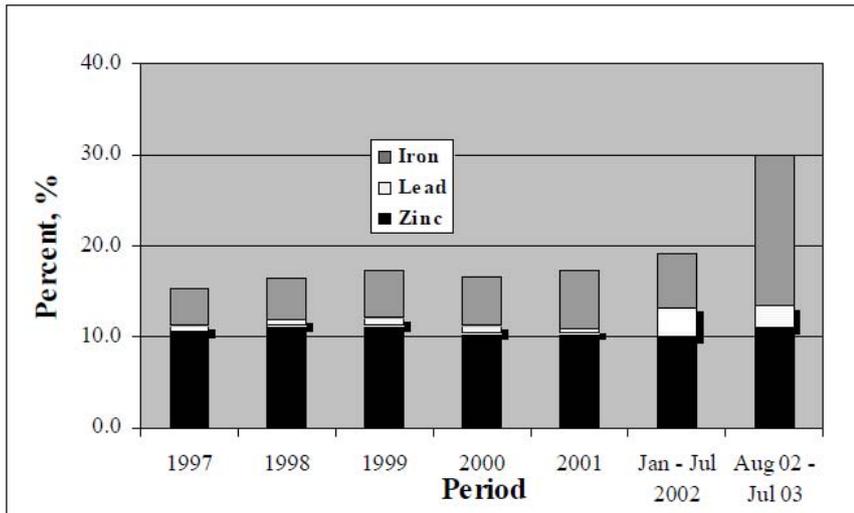
Figure 2: Galmoy Concentrator Head Grade Versus Time

It is clear from the above figure that the quantity of pyrite in the feed to the concentrator increased significantly

(240%) from 5% to 17%Fe as and from August 2002. The head grade continued this profile during the period through to July 2003.

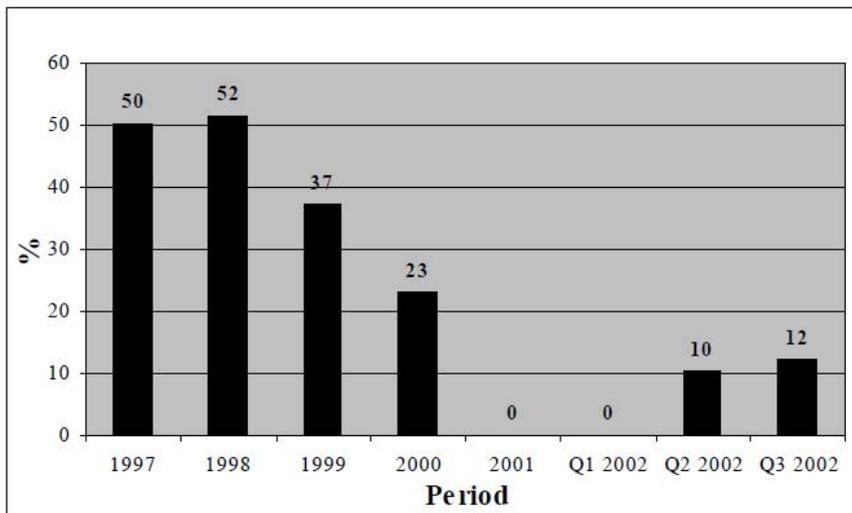
Figure 5: Lead Recovery Versus Time

The culmination of the increased tonnage and pyrite loading on the grinding and flotation plants resulted in unsaleable lead concentrates being produced due to higher iron department to lead concentrates. This was primarily due to the lead circuit only having one stage cleaning. Figure 5 shows the downward trend in lead recoveries and note that at times of lower head grades during 2001 and 2002, the lead circuit was not operated.

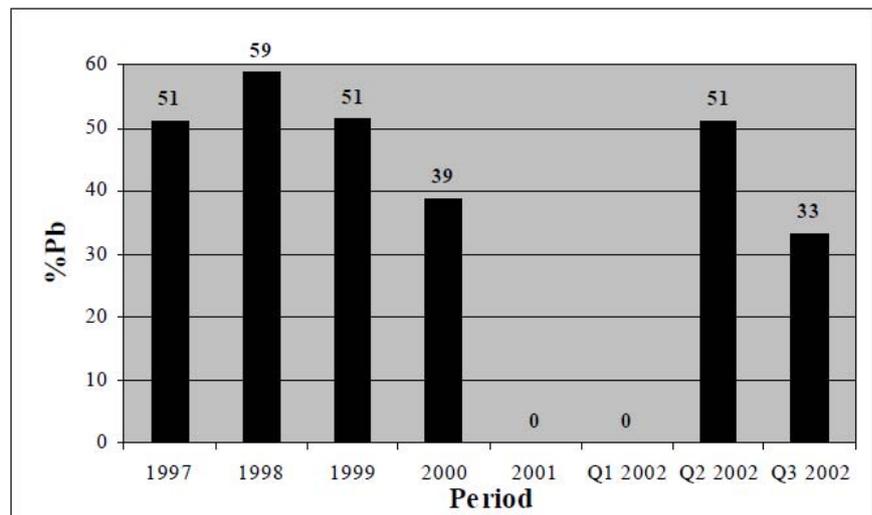
Figure 6: Lead Concentrate Grade Versus Time

Figure 6 shows the concentrate grade trend versus time. Traditional lead concentrates have always been relatively low grade due to the low head grade and lack of multiple stage cleaning circuit.

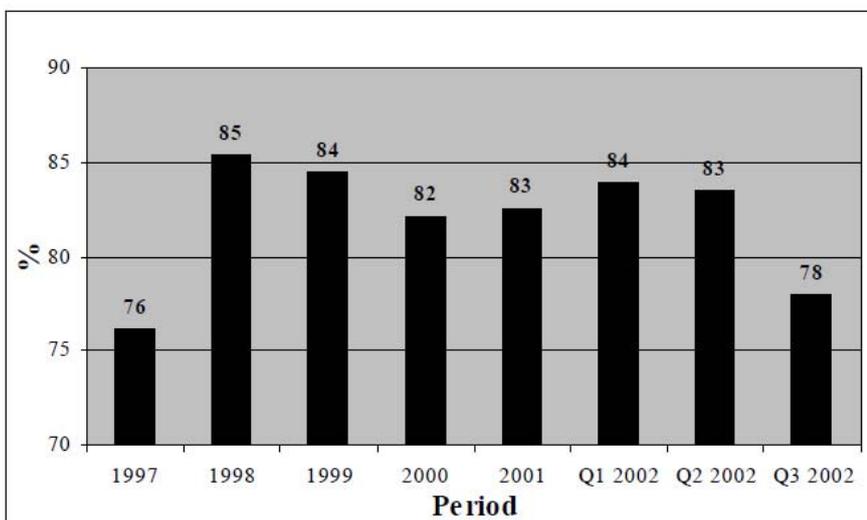
Figure 7: Zinc Recovery Versus Time

Figure 7 shows the fall in zinc recovery in the third quarter of 2002 from traditional levels of 83% to 78%.

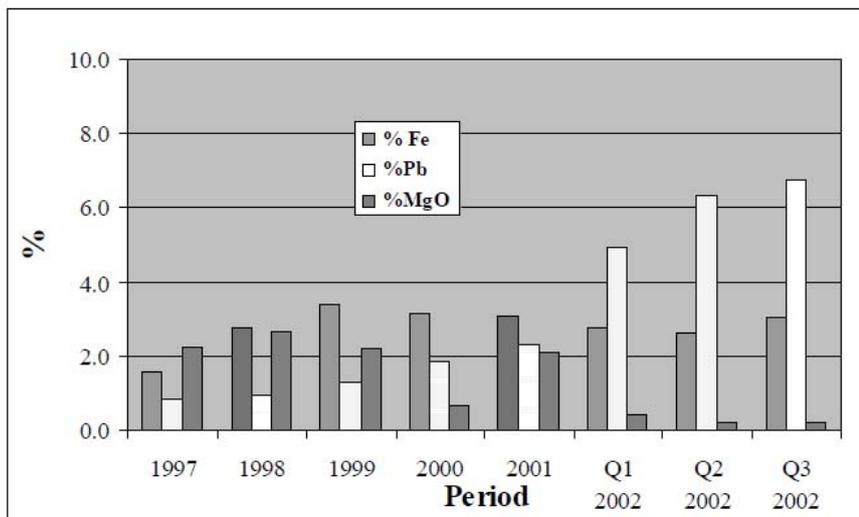
Figure 9: Zinc Concentrate Contaminants Versus Time

However, the traditional zinc concentrate contaminant finger print (Normally MgO driven) changed to a lead driven issue. Refer to Figure 9 below.

The main reason for this was the lack of adequate lead cleaning capacity, which resulted in a fine balance being drawn between minimizing zinc loss to lead concentrates and recovery of lead from the circuit upstream of the zinc circuit.

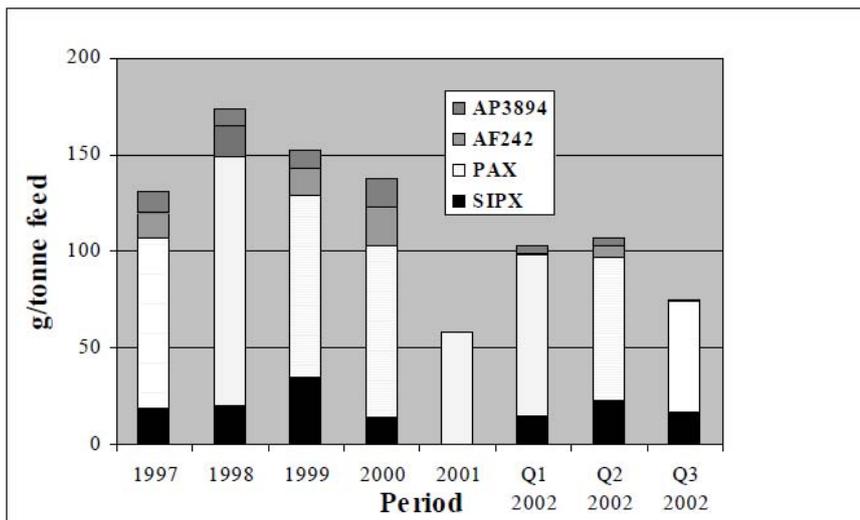
Figure 10: Collector Dosages Versus Time

Referring to Figure 10 below, note how the collector additions to the circuit (PAX and AP3894 to the zinc circuit and SIPX and AF242 to the Lead circuit) decreased with time. PAX (Strong collector) was being dosed to the zinc circuit whilst SIPX (Medium strength collector) was being dosed to the lead circuit. As a consequence, recovery of lead was higher in the zinc circuit than in the lead circuit.

On October 3rd 2002, the primary collectors (PAX and SIPX) were switched such that PAX was dosed to the lead circuit and SIPX dosed to the Zinc circuit. This rationale was due to the fact that lead tends to slime readily during grinding and required

stronger collector than the zinc circuit. Lead recovery increased immediately and lead contamination of zinc concentrates was significantly reduced.

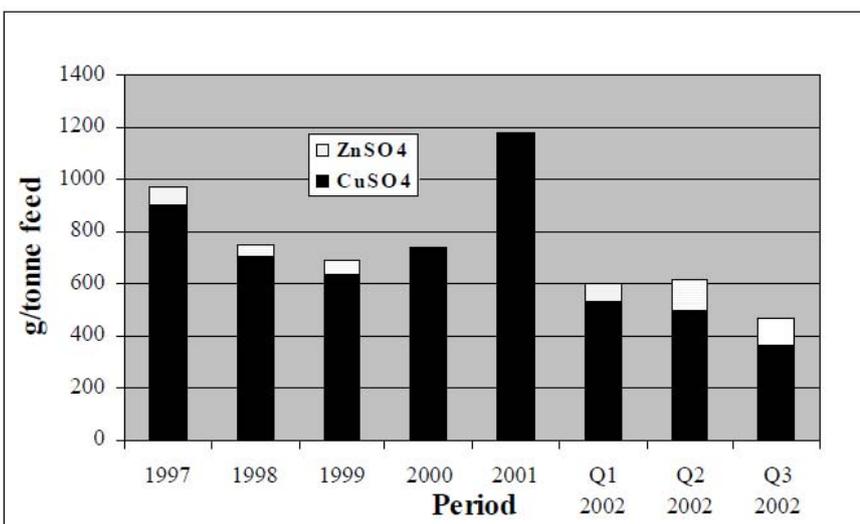
Figure 11: Zinc depressant and Activator Dosage Versus Time

Note in Figure 11 above, how the zinc activator dosage reduced over a period of time whilst zinc depressant dosage increased.

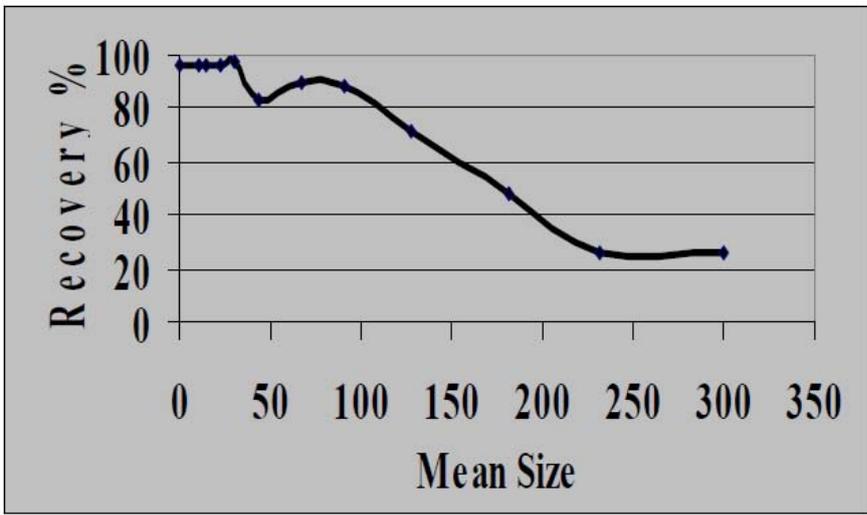
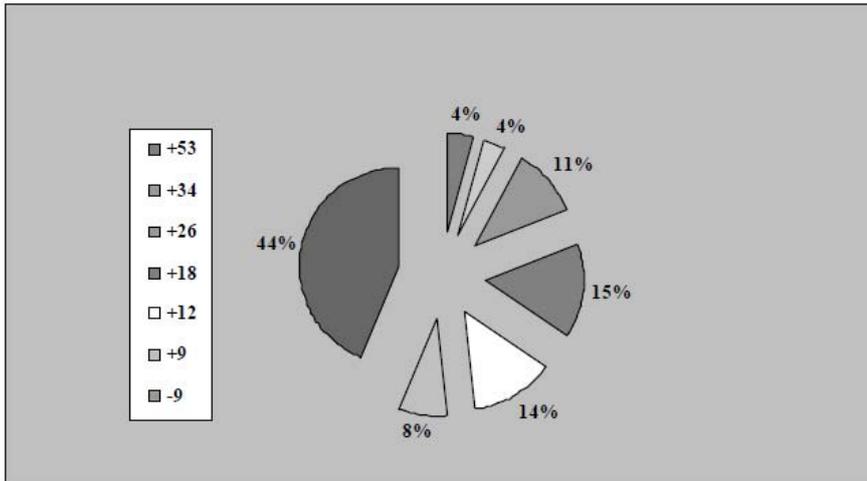
20) and the final zinc concentrate zinc distribution by size (refer to Figure 21 below), indicated that the majority of the zinc was floating below 50 microns.

A significant proportion of the zinc is in the minus 9 micron fraction.
